| | | RG-IIB-K75A | RG-IIB-K86A |

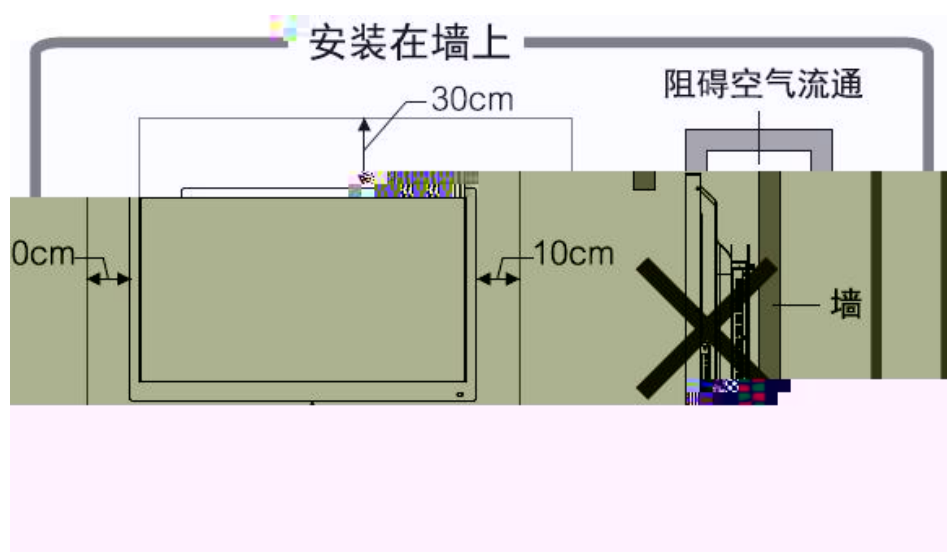
A

1

2 M4

160KG
